# Fire behaviour of steel members penetrating concrete walls

I. D. Bennetts and C. C. Goh

Centre for Environmental Safety and Risk Engineering, Victoria University of Technology,  
Werribee Campus, Victoria, Australia  
Email: [ian.bennetts@vu.edu.au](mailto:ian.bennetts@vu.edu.au); [chongchee.goh@vu.edu.au](mailto:chongchee.goh@vu.edu.au)

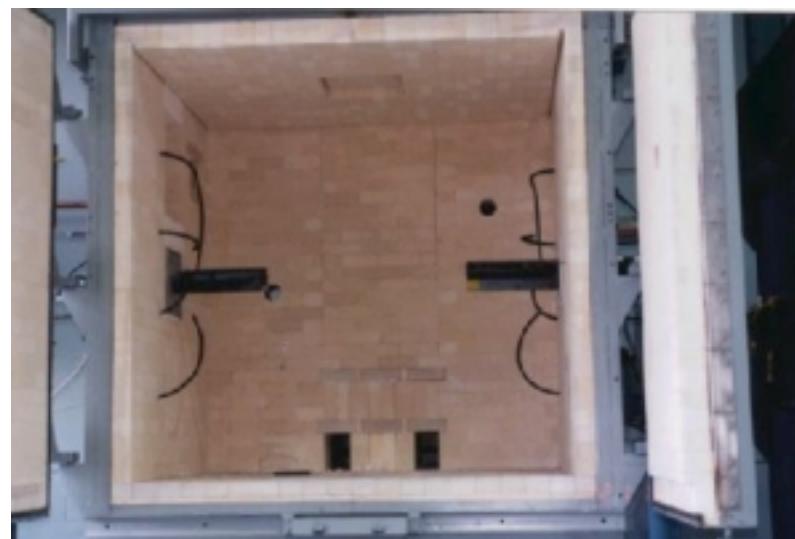
**Fig. 3 - Overall view of test set-up**

The tests were conducted in a standard fire test furnace which internally measures 2.1 m width  $\times$  1.8 m depth  $\times$  2.1 m height. Fig.3 shows an overall view of the furnace with two test specimens mounted in the side walls of the furnace.

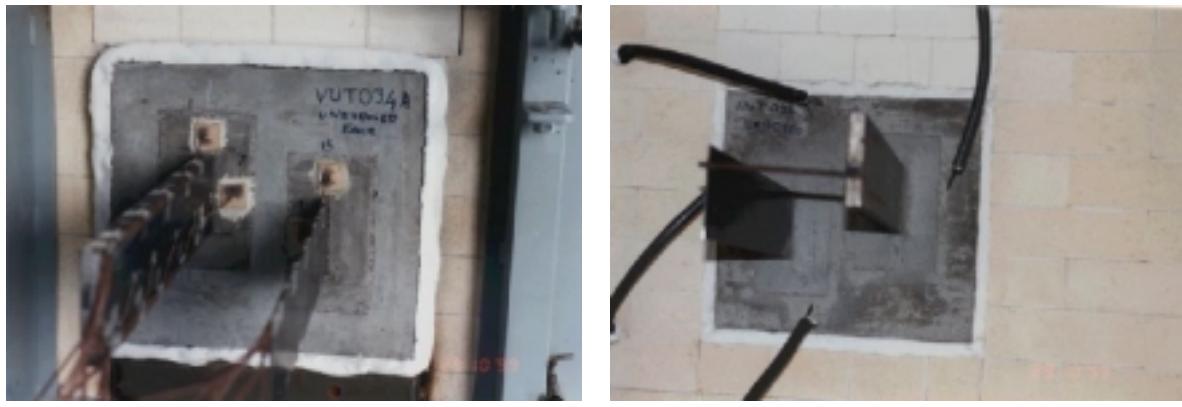
(a) Thermocouples at unexposed face of test specimen

(b) Thermocouples at exposed face of test specimen

**Fig. 8 - View of thermocouples on test specimen**

Figs 8(a) and (b) show the unexposed and exposed faces of a test specimen positioned on one side of the furnace wall with its associated thermocouples.

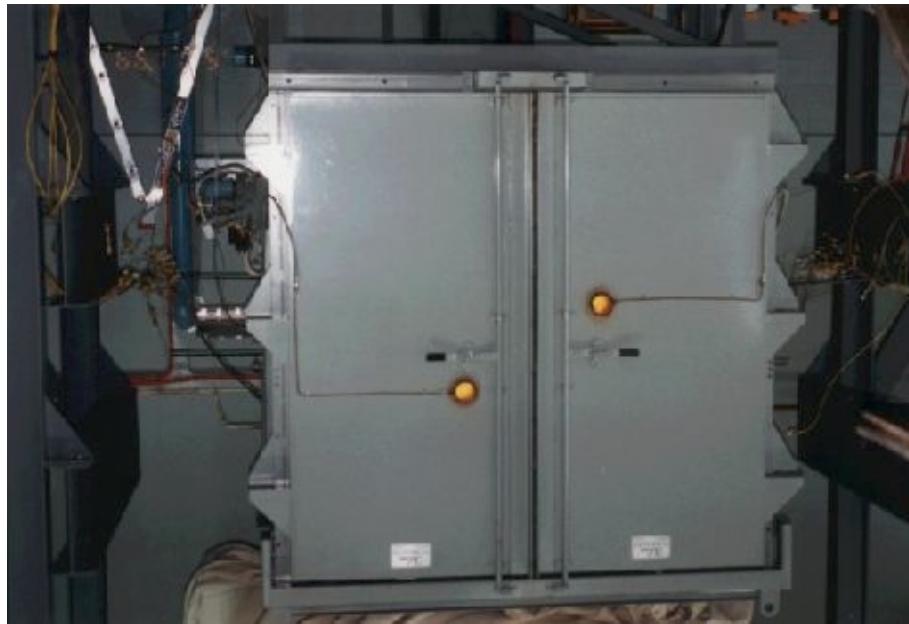
**Fig. 9 - View of furnace during test**

Fig. 9 shows an overall view of the furnace. The unexposed face of the steel plates of one of the specimens can be seen at the right-hand side of the furnace.

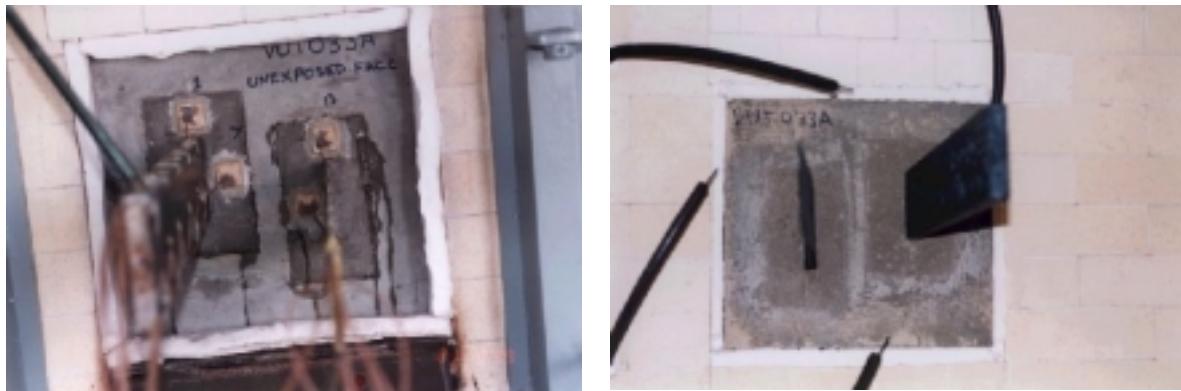
**Fig. 15 - Test VUT033**

(a) Unexposed side

(b) Exposed side

Figures 15 to 18 show photographs of specimens on the unexposed and exposed sides of the concrete block at the end of the tests. The steel plates directly exposed to the fire showed signs of oxidation (blistering) and the 2 mm plates have also distorted. However, this effect is not evident at all on the unexposed side.

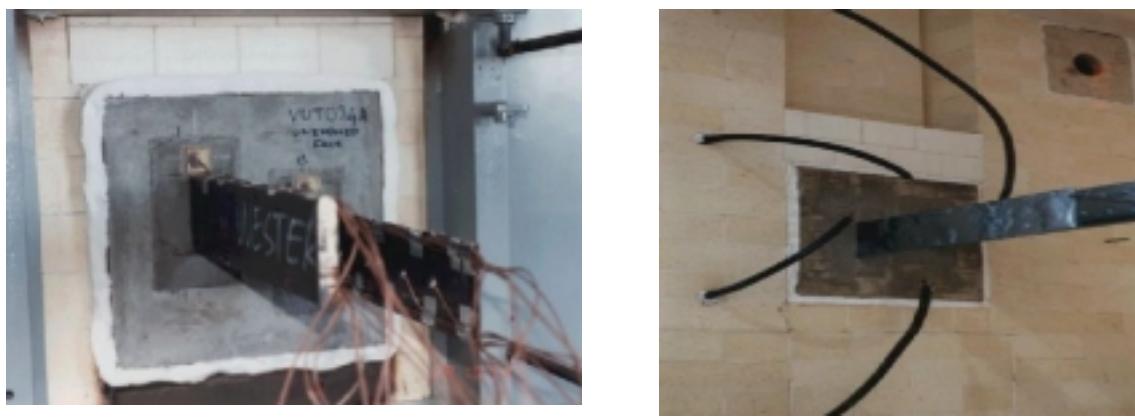
**Fig. 16 - Test VUT034**

(a) Unexposed side

(b) Exposed side

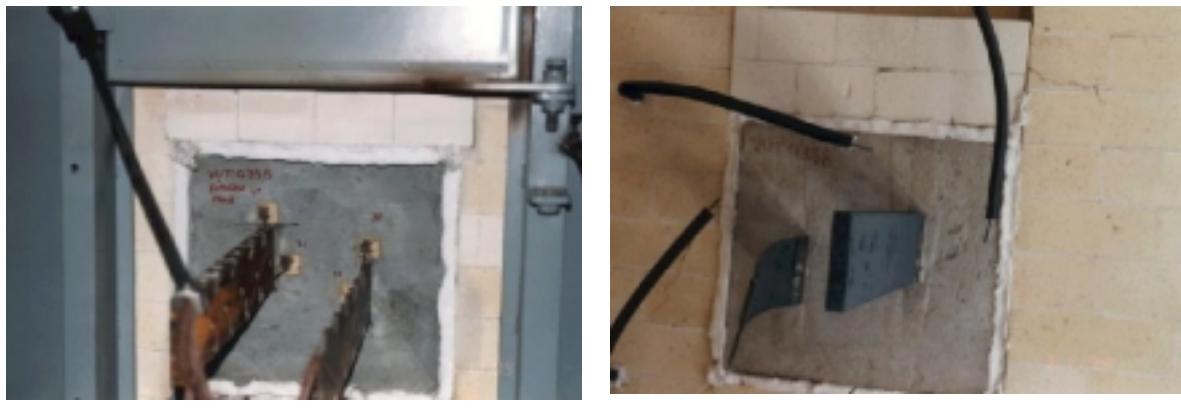
**Fig. 17 - Test VUT035**

(a) Unexposed side

(b) Exposed side

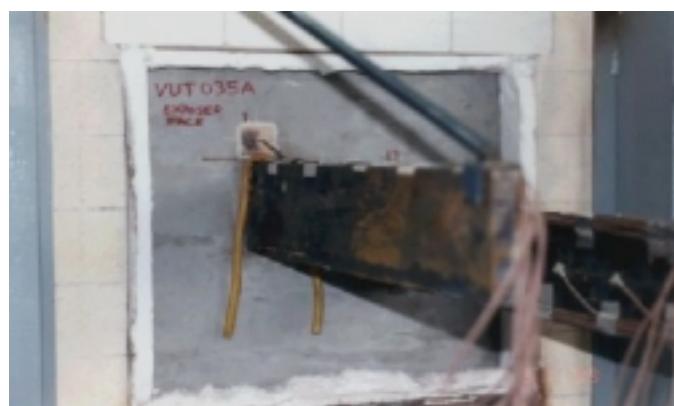
**Fig. 19 - PVC cable hung from steel plate**

As described earlier, non-fire-retarded PVC cables and a piece of cardboard were attached to the hottest steel plate next to the unexposed side of the concrete wall towards the end of each test (see Figs 19 and 20). In this test (VUT035), the temperatures of the steel plates near the unexposed side of the concrete wall were about 265°C and 259°C for specimens VUT035a and VUT035b respectively. After about 12-13 minutes of exposure, no ignition occurred except that the PVC cable melted and the cardboard lightly scorched, as shown in Fig. 21.

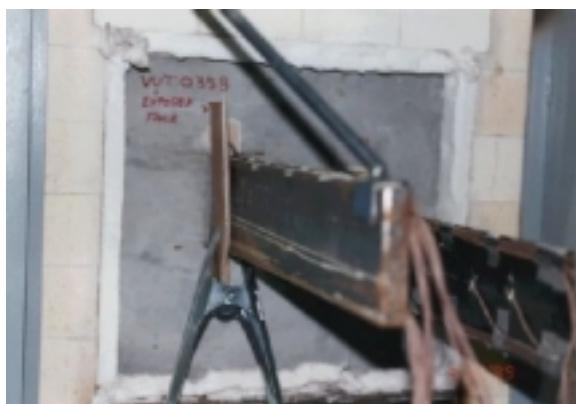
**Fig. 20 - Cardboard attached to steel plate**

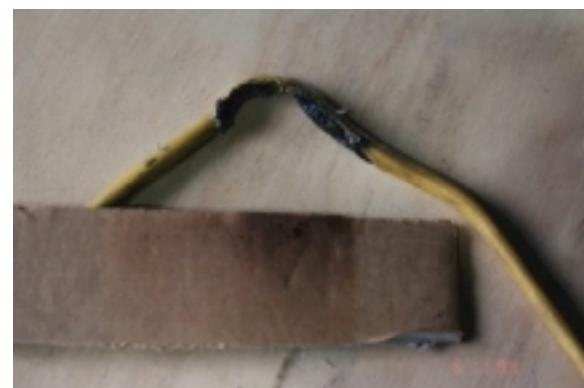
**Fig. 21 - Conditions of PVC cable and cardboard after 12-13 minutes of exposure**
