Strengthening and Rehabilitation of RC Beams with FRP Overlays under Combined Shear and Torsion

ABSTRACT: This paper deals with evaluating the rehabilitation convenience of a damaged RC beam under the combined shear-torsion effect and retrieving its shear-torsion capacity by using FRP rolled strips. To this end, 9 specimens with 2.85 m lengths and clamped-clamped boundary conditions were made and tested under combined shear and torsion up to fracture (from zero loading eccentricity, corresponding to pure shear, to infinite eccentricity, due to pure torsion). Five of the specimens were ordinary (control) specimens considered as reference and four of them were strengthened with FRP strips from the beginning. Also, four of the ordinary specimens were rehabilitated after fracture by rubbing cement mortar on the cracked faces, then strengthened and tested like other specimens. Results indicated that rehabilitating and strengthening the beam will not only retrieve the initial shear-torsion capacity, but also increase the ultimate capacity up to 60 %. The increased capacity for the specimens strengthened from the beginning was 97%.

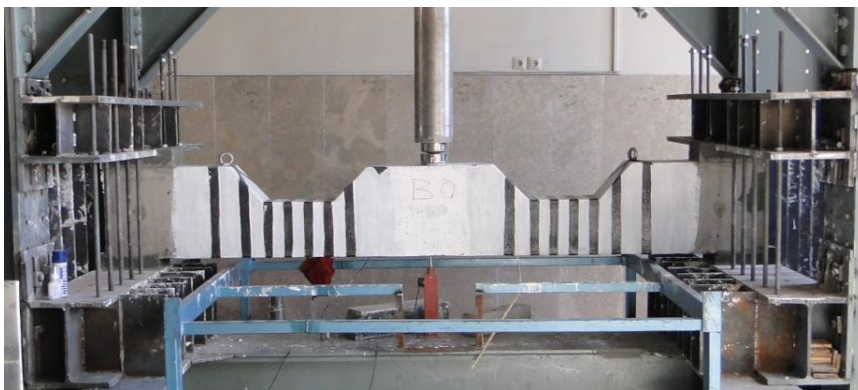
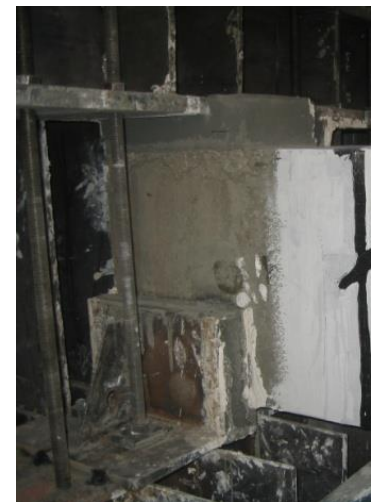
Figure 2. (a) Flexural rigid support, (b) torsional support

In order to make a flexurally-clamped support, an H-shaped metal deck, constrained at the top and bottom of the beam, was placed at each end as shown in Figure 2a. Each deck had a 2 m length and the loading axis was constantly placed at the middle of the assemblage, and the beam was seated on a different point of the lower H-shaped deck in each eccentricity. The top and bottom decks were connected from two sides, one with stiffeners and the other with bolts which are screwed after the beam had been placed on the eccentricity place. Also, in order to forestall any small flexural rotation on each end, grout was poured between the bottom of the section and the lower deck, and between the top of the section and the upper deck. In order to make the support torsionally-clamped, two L-shaped elements, stiffened by triangular plates, were connected to the decks on the top and bottom of the section as shown in Figure 2b. Also, in order to forestall any small torsional rotation on each end, grout was poured between the beam sides and the stiffened elements.

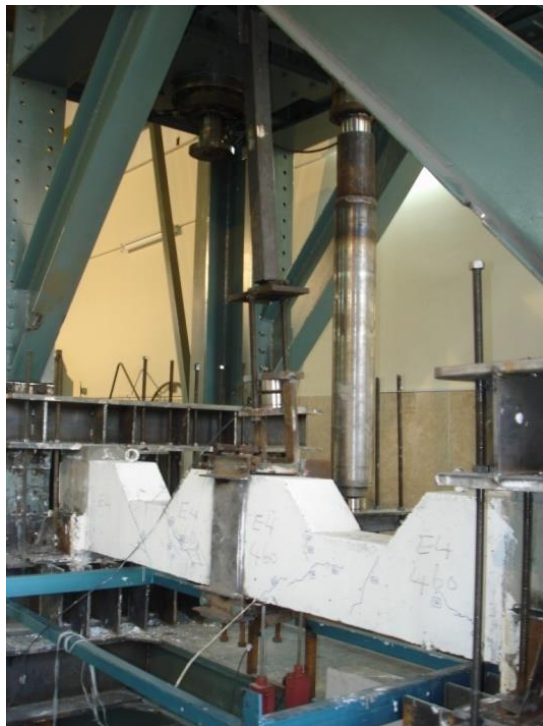
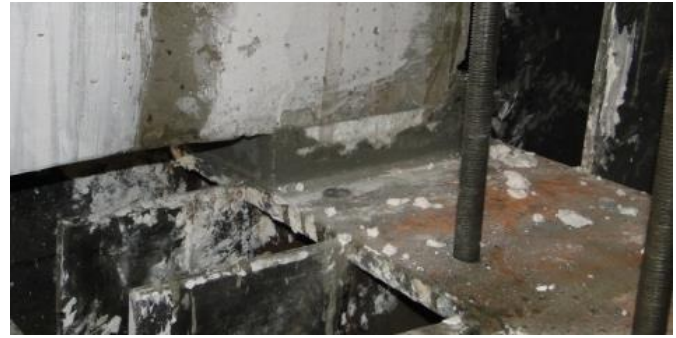
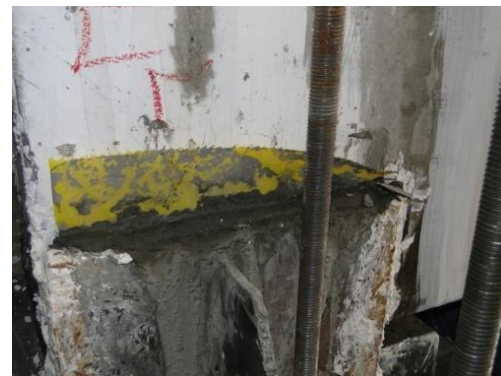
Figure 3. Pure torsion test setup; (a) vertical shear compensating member (b) polystyrene plate between the bottom of beam and lower grout; (c) plastic thin film between side of beam section and side grout

When pure torsion was needed, an inside support was placed at the middle, acting as a compensator for torsion preventing shear and bending. This inside support was, as portrayed in Figure 3, a two-hinged rod carrying the whole shear force exerted by the hydraulic pump. For assurance of the true behavior of this support, foam plates were placed at the top and bottom of the beam section at the two ends before pouring grout. Thus, the end supports did not have contribution in carrying the imparted shear force, and the whole force was transferred to the inside support. The load cell placed under this rod over the metal belt indicated that the load exerted on the lever connected to the belt was fully transferred to the rod. Thus, bending and shear won't be created in the structure.

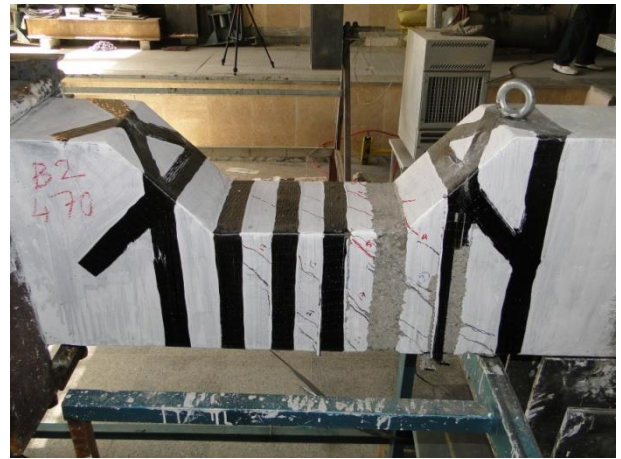
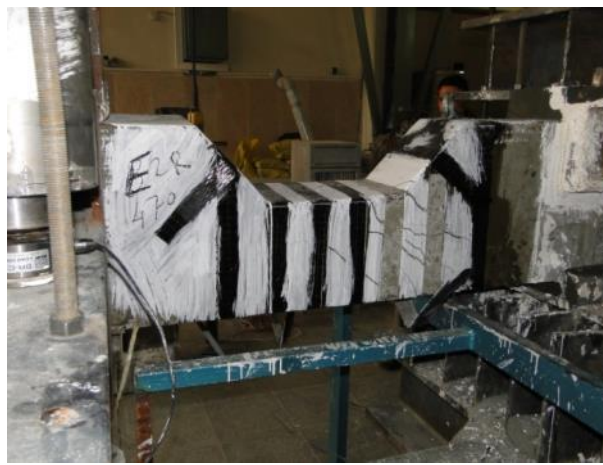
Figure 8. Cracking of face #2 for specimen; (a) E2; (b) B2; (c) E2R

All cracks were observed to have an inclined pattern due to the purely shear or shear-torsional behavior of specimens. Moreover, in all specimens under shear-torsional or purely torsional loading, face 2 (shown in Figure 7) was cracked at first. Cracking was then followed on faces 3, 4, and 1, or 3, 1, and 4. However, in purely shear loading, cracking occurred on faces 2 and 4 simultaneously. All the observed cracking patterns, including the spiral-like (torsional), diagonal (shear), and intermediate (shear-torsional) cracks conformed well to the contents of the existent literature [19, 20]. Figure 8 shows examples of cracking on the fracture threshold, which pertain to *E2*, *B2*, and *E2R* specimens (undergoing a 470 mm eccentricity).

All the same, in rehabilitated specimens, cracking was initiated and developed up to fracture on face 4. It is noteworthy that the placing of these specimens was done such that the twisting direction of the specimen be exactly the same as that in the ordinary specimen. Moreover, some sporadic cracks were also observed on face 2. Also, the rehabilitated specimens were observed to deform largely on the fracture threshold, such that a rigid-body motion was seen at the cracked zone, around the beam horizontal axis.
