An Experimental Study of Reinforced Concrete Façade Panels and Their Fixing Assemblies Subjected to Blast Loads

ABSTRACT: This paper presents experimental studies of concrete façade response to blast pressures. The experimental program also aims to establish the influence of fixings assemblies on the performance of pre-cast concrete façade panels. The current standardized approach of pre-cast concrete design as defined in UFC3-340-02 limits the support fixity of pre-cast wall panels to be a simply supported system. The restriction to a simply supported system in a pre-cast wall panel would lead to inefficient design due to non-optimized use of concrete panel thickness. The experimental results showed that varying fixing assemblies may lead to a partial fixity condition, which is not accounted for in the UFC3-340-02 design guideline. The partial fixity conditions observed in the experimental results indicate that there are residual capacities in the pre-cast façade systems. The efficacy of the façade panel system could be improved by taking into account partial fixity in the support system. Similarly, premature shear failure could also be prevented by understanding the additional c

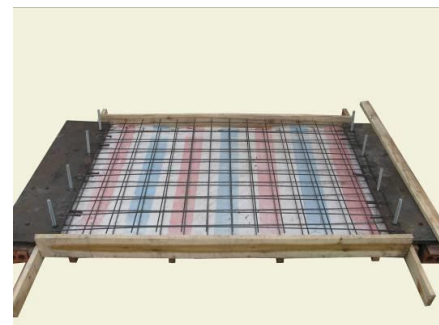
(a) Reinforcement detailing

Figure 1. Details of Type A panel

The panels are divided into two major types. Type A, which represents the baseline specimen; and type B, which represents varying fixing assemblies. The exact length of the panel varies slightly as panel type B requires extra 200 mm length to maintain an approximate equivalent clear span to type B specimens. Both panel types were reinforced with two layers of N5 steel reinforcement mesh having a minimum cover of 10 mm. The reinforcement mesh spacing was set to a constant value of 100 mm. The reinforcement details for two panel types are shown in Figure 1 and Figure 2 respectively.

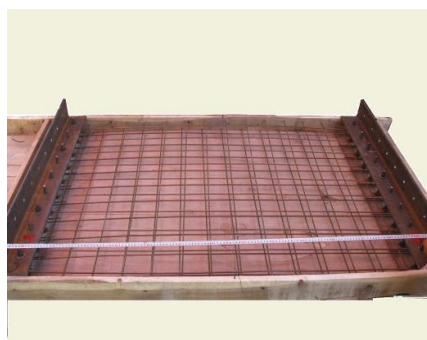
(a) Reinforcement detailing

Figure 2. Details of Type B panel

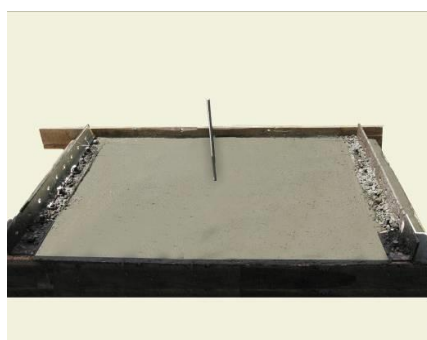
(b) Casted panel

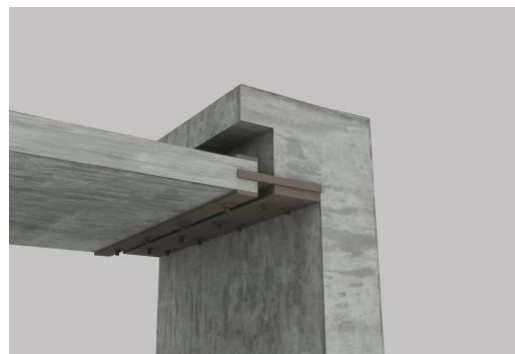
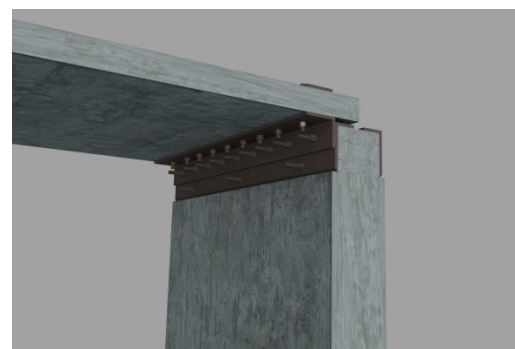
(a) Type A

(b) Type B

Figure 4. Connecting panels to test bunkers

Panel type A was connected to the test bunker through a 20 mm thick steel plate and 8 M18 bolts. The angle cleat thickness, number of bolts and bolt sizes were varied to achieve different fixing stiffness in panel type B and are given in Table 2. Type A and type B connections are illustrated in Figure 4. Specimen B1 and B2 are defined to establish the influence of the angle cleat of the system, whilst specimen B2, B3, B4 and B5 are defined to establish the fixity influence of the bolts on the fixity of the system.

Intuitively, panel B2 will have a higher rotational stiffness compared to specimen A due to the rotational rigidity of the connections (Figure 4). Therefore, the inward displacement of specimen A as compared to specimen B2 is justified. The crack pattern on panel A exhibits a significantly larger crack width as compared to specimen B1 and specimen B2. The comparisons between specimens A, B1 and B2 have shown that the rotational rigidity of the fixings assembly influences the performance of the panel. Specimen A appears to have the least rotational rigidity in its fixings assembly, whereas specimen B2 appears to exhibit the most rotational rigidity in its fixings assembly. The most significant damage (observed based on the crack development) can also be observed in specimen A in comparison to specimens B1 and B2, whilst least damage was observed in specimen B2.

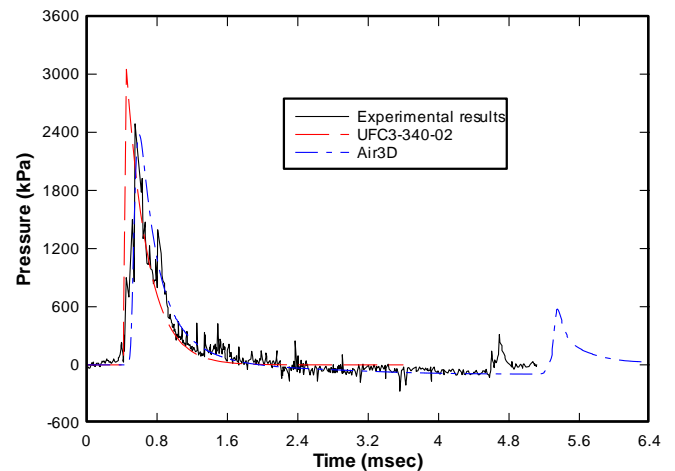
Figure 6. Reflected pressure time-history comparison

weight for UFC3-340-02 and Air3D was used as 5.5kg of TNT, using the TNT equivalency factor of 1.1 for Ammonite. Table 3 shows the comparison of peak reflected pressure and peak reflected impulse of the blast trial and Figure 6 illustrates the time history comparison of blast pressure for 5kg Ammonite.

It was observed that UFC3-340-02 parameters overestimated the peak reflected pressure, and Air3D underestimated the peak reflected pressure. However, the comparison of peak reflected impulse was in general agreement with the values recorded in the experiment, as illustrated in Table 3.
