# Reinforced Concrete Beams and Slabs with Bonded CFRP Laminates: Strain Compatibility Paradox

**ABSTRACT:** Externally bonded Fibre Reinforced Polymers (FRP) Laminates have been extensively used to strengthen reinforced concrete beams and slabs in flexure. Most design codes of practice provisions assume full strain compatibility between the FRP laminates and the concrete section in order to estimate the moment resistance of this hybrid system. However, as shown here, strain compatibility is lost during the early stages of loading. The current design methodologies account for premature failure due to interfacial crack debonding mechanisms by limiting the strains in the FRP to low values, resulting in the use of only a small portion of the FRP laminate capacity. Experimental investigations previously performed on precast bridge girders, hollow core slabs, and beam specimens – all with CFRP laminates bonded to their soffits – highlight the loss of strain compatibility and interfacial debonding. In this paper, recommendations are presented in order to tackle both issues.

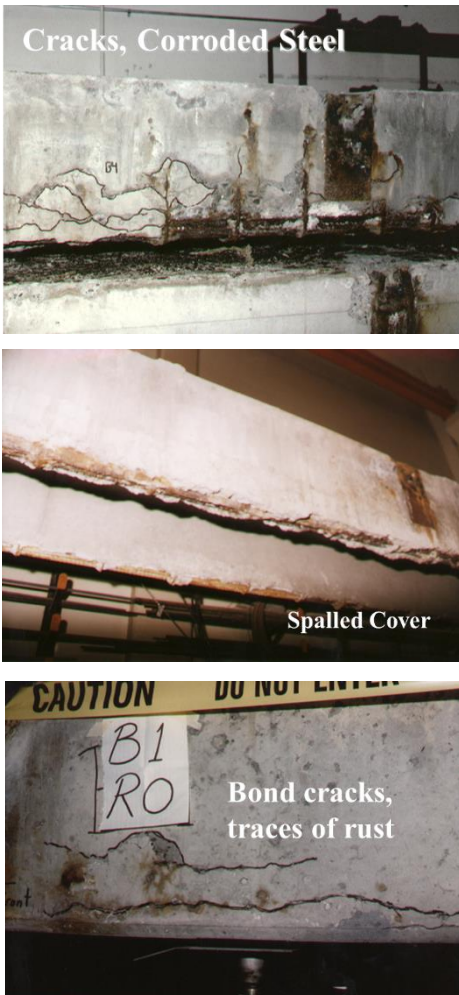
Fig. 2. Cross section and section elevation of an HC-Type precast bridge girder (above) and current girders state (below).

HC-Type precast girders (Fig. 2) have an inverted U cross-section and are placed, simply supported, beside each other to form the base of the bridge deck. The girders tested were 11.6 m long. Over their service years, these girders had developed major problems. The initial concrete cover provided was too small in comparison to the amount of steel reinforcement; the cover is also deemed to be inadequate based on the current design code. As a result, cracks appeared around the reinforcement, exposing most of the steel in the mid-spans of the girders, with rust developing in the steel bars (Fig. 2).

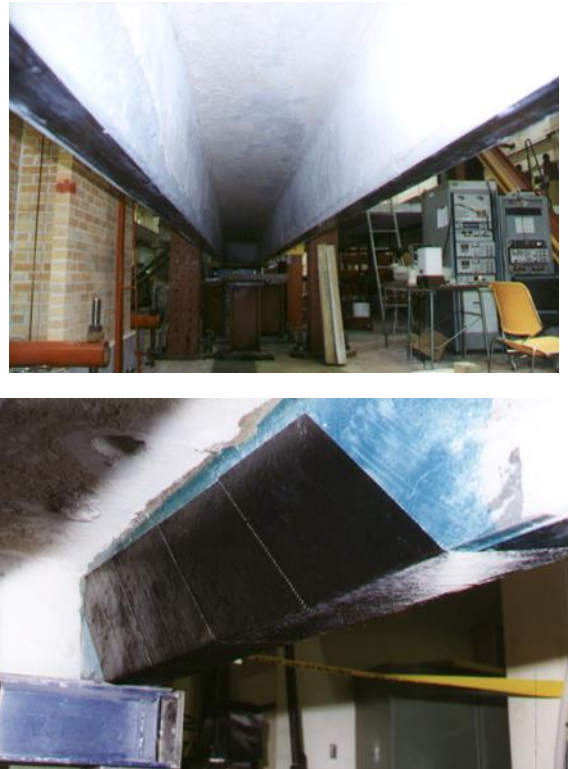
Fig. 3. HC-Type Girder after rehabilitation using CFRP strips bonded to the soffit of the web (left) and CFRP sheets bonded at the end of the web (right).

Two girders were patched, strengthened with CarboDur® S1012 CFRP strips (1.2 mm thick  $\times$  100 mm width) and Replark® CFRP-sheets (0.12 mm thick  $\times$  250 mm width) and tested in flexure using a 4-point load scheme (Fig. 3). The CFRP strips are used to

strengthen the girders in flexure while the sheets are used to increase its shear strength and anchor the strips at their ends. The modulus of elasticity, the tensile strength and the maximum elongation of the CFRP strips are 165 GPa, 3050 MPa and 1.7, respectively; while those for the CFRP sheets are 230 GPa, 3400 MPa and 1.55%, respectively.

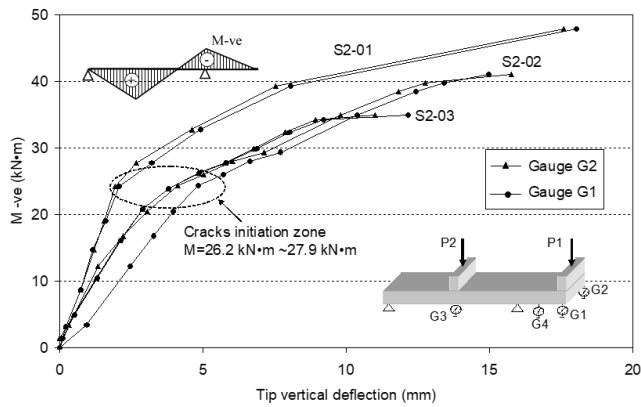
Fig. 8. Negative moment versus cantilever deflection for hollow core slabs with top-longitudinally bonded CFRP strips.

The cantilever tip displacement is plotted against the negative moment over the support in Fig. 8. Only negative moment resistance was considered since the objective of these tests was to increase the strength of HCS when they have the unusual cantilever as mentioned earlier. It is evident from Fig. 8 that bonding the CFRP strips to the precast-prestressed hollow core slabs significantly increased the negative moment resistance of the slabs. The cracking moments were increased 1.83 to 2.25 times that of the control slabs while the ultimate moments were enhanced by 2.77 to 5.74 times that of the control slabs. However, once again failure occurred prematurely due to interfacial debonding.

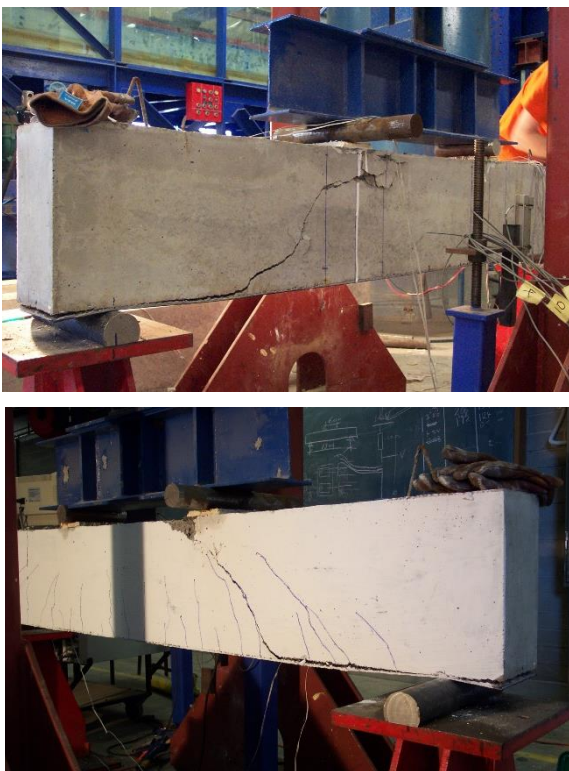
Figure 15. Failure of Beam 7 in shear acting interactively with diagonal crack-induced interfacial debonding of the CFRP.

For Beams 7 and 8 with “low” concrete strength and “low” shear reinforcement, a distinctive mode of failure was evident (Fig. 15). Shear failure was the primary mode, but acting interactively with critical diagonal crack-induced interfacial debonding. During loading, a shear crack developed and traversed the entire depth of the beam, extending from the location of the external load point to the CFRP laminate. In Beam 7, the crack was steeper in the middle region of the beam than in the upper and lower portions, whereas for Beam 8, the slope was more uniform.

Once the crack reached the CFRP strip, propagation proceeded more slowly than in previous tests back to the support, separating the CFRP strip from the beam, again distinct crack-induced interfacial debonding. At failure, some concrete crushing occurred under a load point. This may have been a localized effect as it only occurred in the vicinity of a point load, but it also suggests the flexural and shear capacities of the beams were nearly equal.
