# Use of Non-Destructive Methods: Case Studies of Marine Port and Bridges Structures in Surabaya

Y. Oktavianus, M. Sofi\*, E. Lumantarna, M. Maizuar, P.A. Mendis, C. Duffield & A. Rajabifard

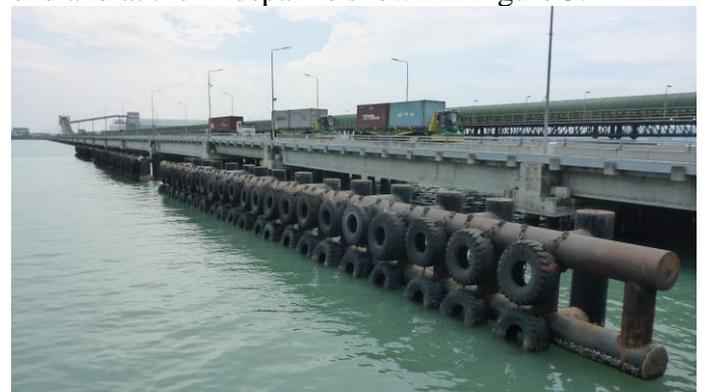
Figure 4. View of the TL bridge from the berth

The TL bridge has post-tensioned RC beams and was built in 2010 as shown in Figure 4. The bridge considered in this research has 20 spans with a length of 40 meters for each span and it connects the office of the Port of Teluk Lamong and the land in Java Island Each. Each span consists of 5 precast segments and is also simply supported on top of the cross beam through rubber bearing. The cross beam is then supported by a group of the spun pile with a diameter of 800 mm and concrete grade of 58 MPa. The cross-section of the I girder of the bridge at the end and at the midspan is shown in Figure 5.

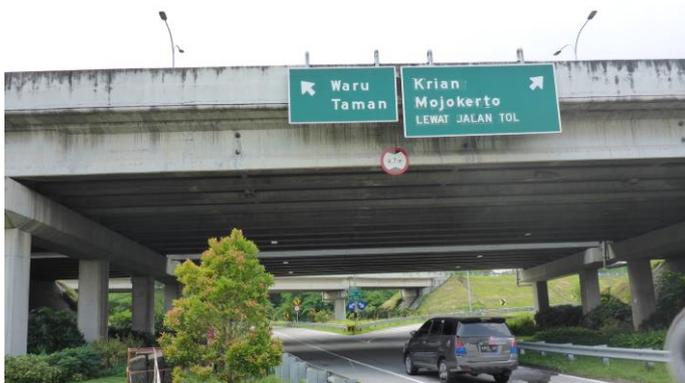
Figure 6. RC bridge in Toll Waru with Pier-1 at the left side of the picture

RC columns have been used as the case study instead of the beam in the case of tollway due to the difficulty in accessing the beam. There RC columns in Pier-1 have been chosen at Toll Waru as shown in Figure 6. The column has a height of 5.46, 5.68, and 5.9 metres from left to right, respectively. The three columns are supporting 10 RC beams with a length of 30 and 16 metres spanning from each side of the column to the adjacent column. The cross-section of the column is shown in Figure 7. The concrete compressive strength of 29 MPa and steel yield strength of 400 MPa was used in the design. The thickness of the concrete cover is 70 mm.

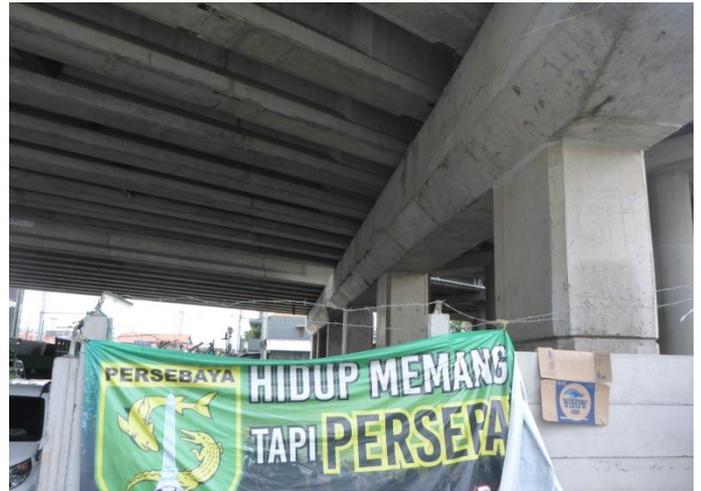
Figure 8. RC bridge in Toll Sumo with the exterior column at the right side of the picture

In toll Sumo, an exterior RC column from the three columns in one pier has been chosen since there was no access to the remaining columns as shown in Figure 8. The column has a height of 4.31 metres. One pier (with three columns) supports 10 girders with a length of 30 metres which are simply supported by the piers.
