Acceptable movements of road embankments

G.P. Papageorgiou, N. Alamanis¹ & N. Xafoulis

General Department of Larissa, University of Thessaly, 41110, Larissa, Greece.

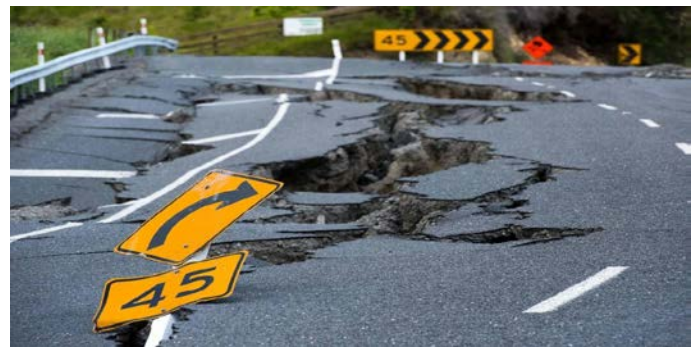
Figure 1. Earthquake damage to State Highway 1 is seen south of Kaikoura on Nov. 16.

There are many recorded cases of road embankments failures either due to poor condensation or due to seismic vibration and oscillation. As a result of the above, sliding, caving and rupture of the pavements that are based on the surface of the embankment. The impact of road degradation on the environment is important because it not only causes pollution in the atmosphere but also affects the ecosystems, fauna and flora of the area through which the road axis passes. In the following figures, failures of embankments and pavements from New Zealand (2017) and Kozani, Greece (1995) earthquakes are presented. Thus, environmental disruption can easily be ascertained, both during destruction as well as during restoration of the road network.

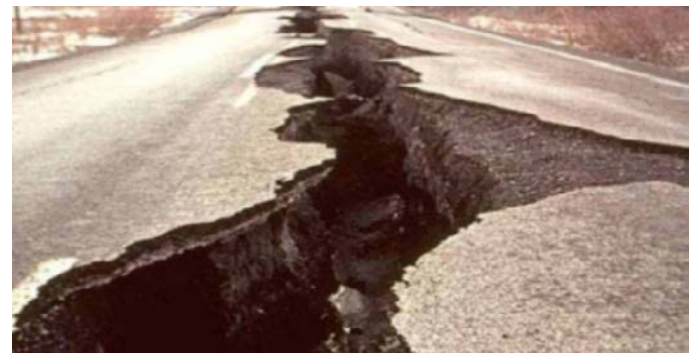
Figure 2. Roadway rupture of the provincial road (Kozani earthquake, 1995)

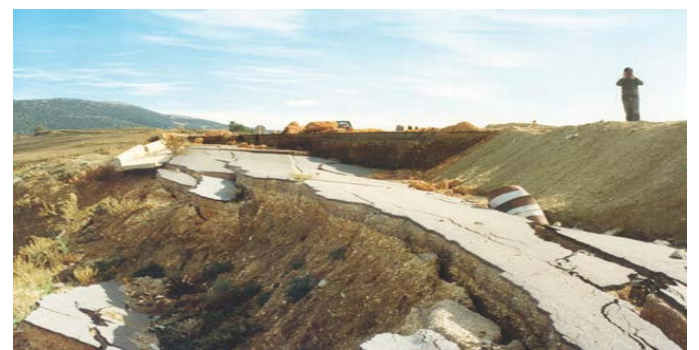
Figure 3. Significant damages to the road network. (Kozani earthquake, 1995)
