Aspects of the Design of Fire-Resistant Plasterboard Walls in Fire

I. D. Bennetts

ABSTRACT: This paper gives the detailed results of a series of fire tests on plasterboard fire-resistant wall construction where that construction was penetrated by steel elements simulating the presence of penetrating purlins or rafters. The tests were conducted to investigate the temperatures experienced by such penetrating elements on the unexposed side of the wall and within the wall itself. The aim of the experiments was to investigate fire spread due to the temperature rise of penetrating elements and whether protection of such elements on each side of the wall is necessary. The experimental work shows that for practical fire wall construction, typical of which is likely to be found in warehouse construction, the temperatures achieved by the steel members on the unexposed side of the wall are not sufficiently high to cause fire spread. It is concluded that protection of the penetrating roof members is not required. Since fire walls are often used in single storey buildings, where the roof structure is mostly unprotected, it is important to ensure that a fire wall is not damaged by the deformin

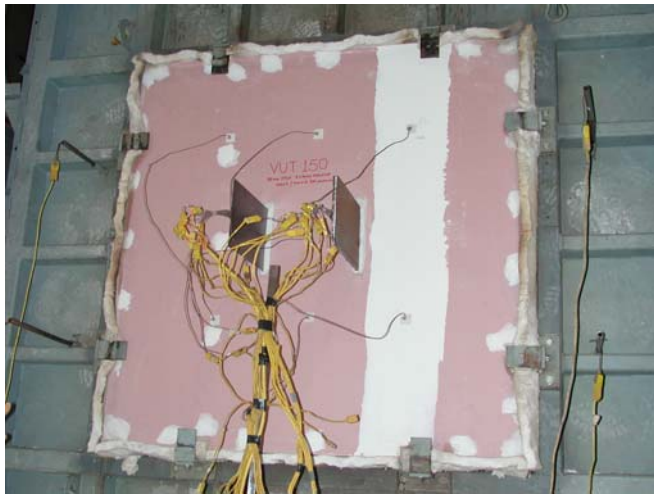
Figure 1 Overall View of Test Set-up

The tests were conducted in a standard fire test furnace that internally measures 2.1 m width × 1.8 m depth × 2.1 m height. Figure 1 shows an overall view of the furnace with a specimen mounted on one side.

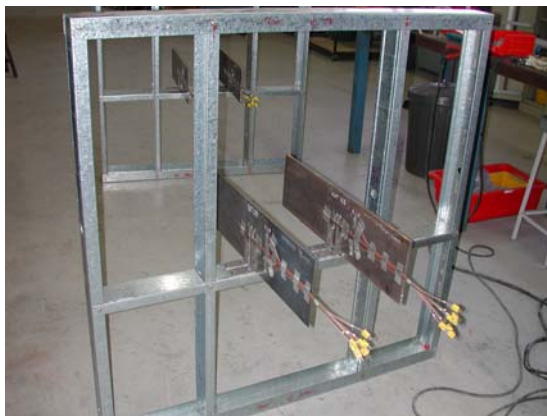
Figure 3 Specimen before Cladding with Plasterboard

Figure 3 shows a specimen during construction, from the unexposed side, prior to fixing the plasterboard sheets. The thermocouples spot-welded to the steel plates can be observed. Test VUT155 incorporated one penetrating steel plate with dimensions 12 mm thick x 200 mm wide x 1200 mm long and a 200UC46 steel member placed within the plasterboard wall. Test VUT157 contained a C20020 Purlin and a 20mm steel plate identical to the one used in test VUT155. In all cases the gaps between the steel plates and the plasterboards were sealed with fire-resistant mastic (PYROPANEL fire-resistant sealant). The plasterboard sheets were cut around the penetrating plates before fixing to the frames.
