Research on seismic safety, retrofit, and design of a steel cable-stayed bridge

ABSTRACT: After the 1995 Great Hanshin Earthquake, Japanese design specification of highway bridges was revised and many piers and bearing supports have been retrofitted. Large span bridges such as arch, truss, and cable-stayed bridges located in bay area of Kobe city also suffered damages from this earthquake. Therefore the investigation of seismic performance of long span bridges has been conducted for large earthquake. The Aratsu bridge constructed in 1987 is a steel cable-stayed bridge of 345m length, continuous three spans, and single plane of stay cables. The seismic performance of this bridge was examined by nonlinear time history analyses using tri-linear back bone and hysteresis loops. Furthermore fiber model analysis and FE analysis are successfully used to check the behaviors of this bridge. According to the analysis of the target bridge, weak members for large earthquake have been clarified. Install of damper and displacement restrainer, and strengthening of components of bearing supports are proposed retrofit countermeasures. The behavior of retrofitted bridge satisfies the criteria of des

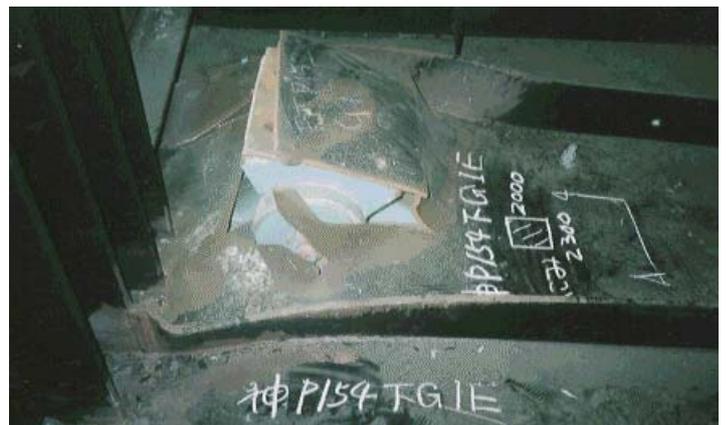
Fig. 1 Penetration of a bearing support into bottom flange.

After the earthquake this highway bridge was not used any longer for a long time. In these damage examples failure of set bolts became the trigger for large damages of bearing supports, girders, and piers.

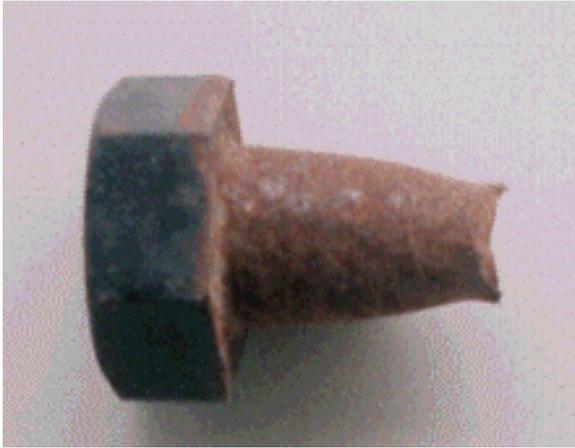
Fig. 2 Failure configuration of a set bolt.

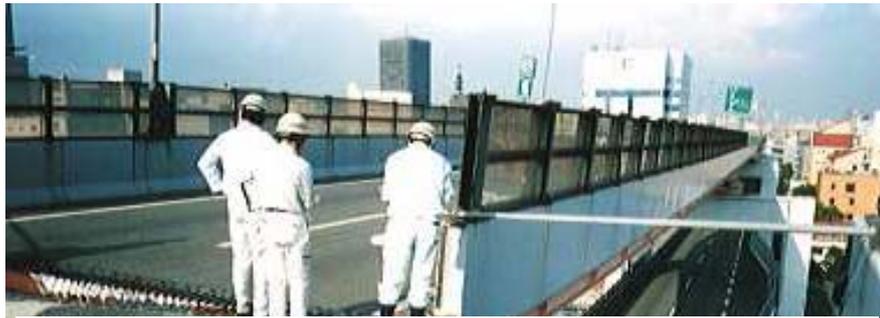
Fig. 4 Relative displacement of girder in transverse direction (about 3.5 m).

The 1995 Great Hanshin Earthquake attacked Kobe city and surrounding area, and caused death of more than 6000 people and many damages of houses, infrastructures such as lifeline systems, and urban highway bridges. After that Japanese specification of highway bridges design was revised and many bridges have been retrofitted according to the new specification. Over-viewing steel bridges damaged by this earthquake, a large number of failures of bearing supports and surrounding members were observed. Fig.1 shows the example in which pin type bearing support penetrated the bottom flange of the box girder. Set bolts of this support were broken by tensile axial forces as shown in Fig.2. Failure of set bolts in upper part of bearing caused the collision of girder and support. In other example shown in Fig.3 we observed the failure of set bolts, fracture of upper part of bearing and scattering of pin roller. Fig.4 shows relative displacement of girder in transverse direction (about 3.5m) which was also caused by the failure of bearing supports.

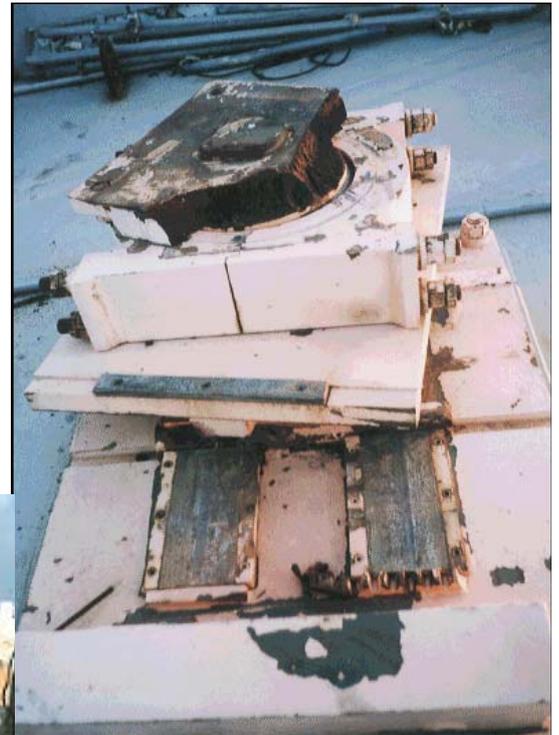
Fig. 3 Failure example of pivot roller support.
